**RAILWAY INVESTIGATION REPORT**  
**R00T0067**

**MAIN TRACK TRAIN DERAILMENT**

**ONTARIO NORTHLAND RAILWAY**  
**FREIGHT TRAIN NO. 402**  
**MILE 63.4, TEMAGAMI SUBDIVISION**  
**TEMAGAMI, ONTARIO**  
**14 MARCH 2000**

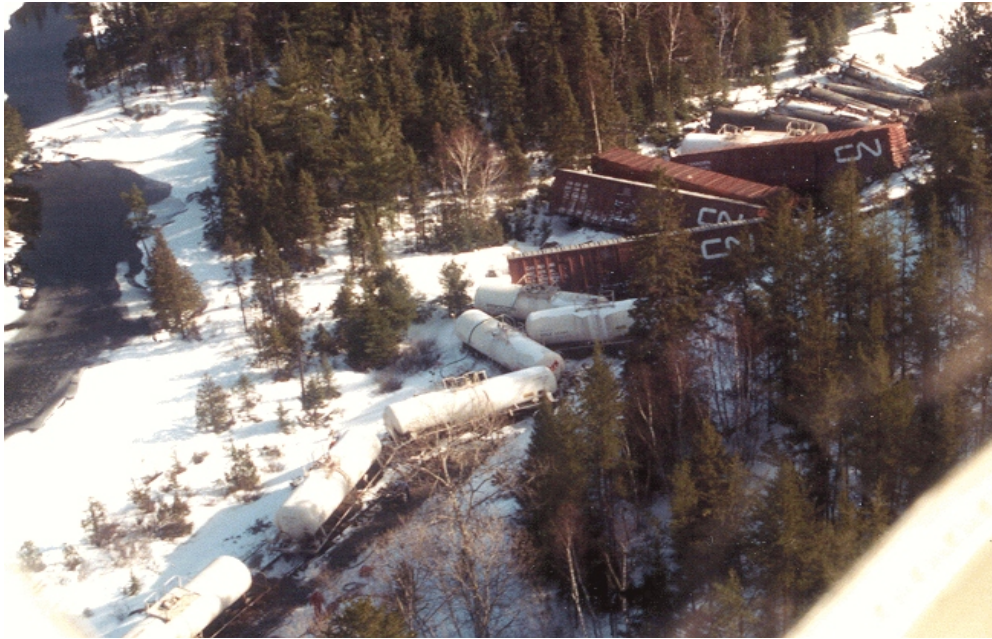
Figure 1 - North end of derailment site

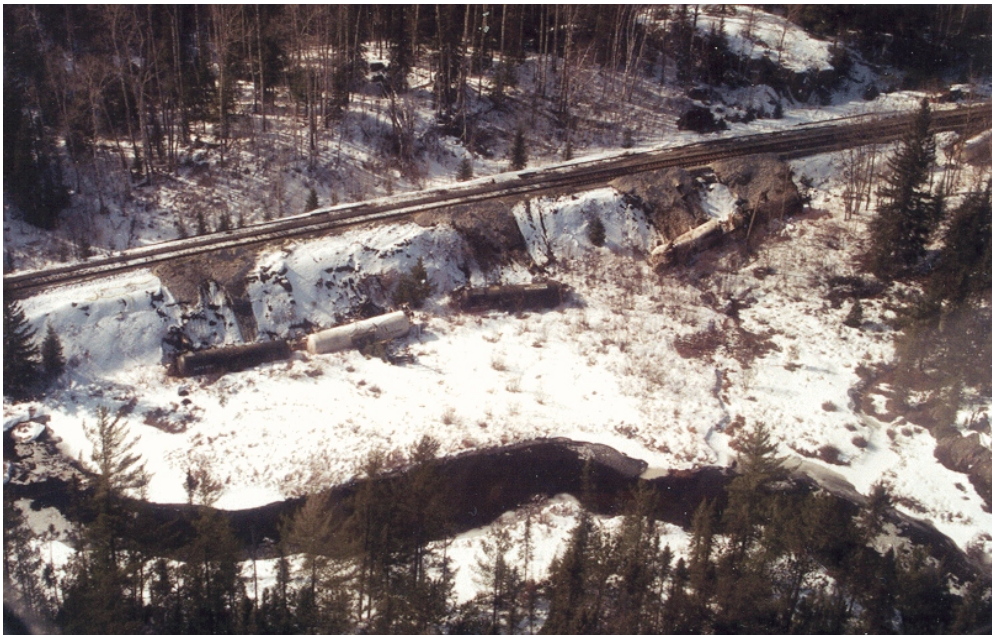
Figure 2 - South end of derailment site

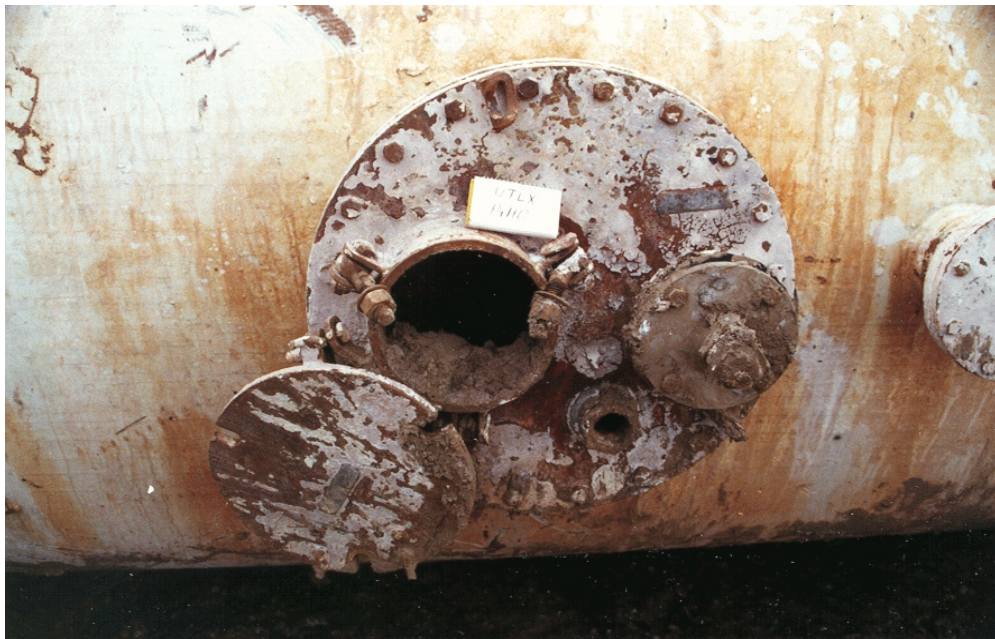
Figure 4 - Top fittings sheared off during the derailment

The derailment again raised the issue of protection afforded to the top fittings on sulphuric acid cars as well as all specification 111 tank cars. In this occurrence, the failure of the top fittings accounted for about 80 per cent of the spilt sulphuric acid. The acid which leaked into the creek and eventually reached and contaminated Hornet Lake came from the cars which had top fitting damage only. The top fitting failure led to the contamination of the watercourse and lake. Improved protection would have reduced the probability of product loss and its impact on the environment. In the past, the failures of unprotected protrusions on specification 111 tank cars have led to accidental losses of sulphuric acid as well as other dangerous goods.
